FERN RIDGE DAM

- PROJECT INFORMATION
- RECENT DEVELOPMENTS
- PRE-EMERGENCY CONDITION
- INVESTIGATION
- REPAIRS

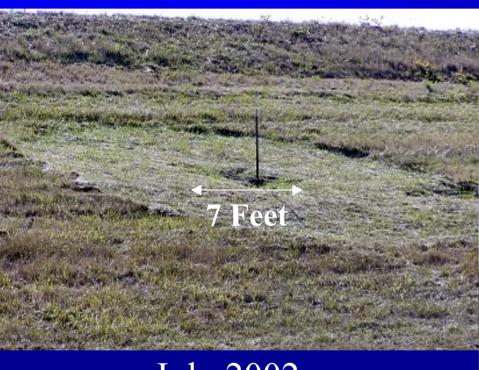
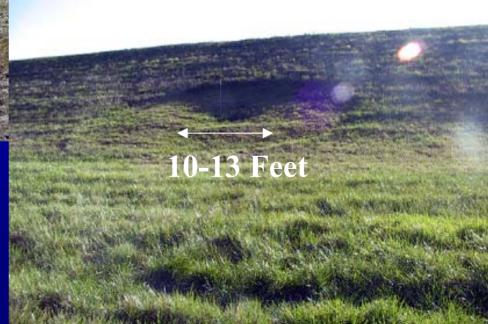
Station 44+00

Location of Depressions

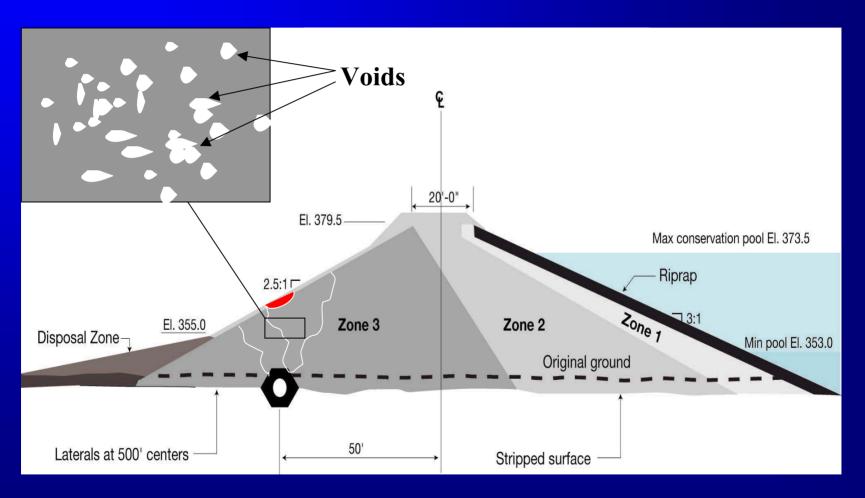
Initial Seepage/Stability Analysis

- Serious Concerns about Embankment Dam
 - Increases in seepage; Settlement or depressions
 - Factor of Safety Is Below Design Standards (Design is 1.5, Estimated Between 1.2 and 1.3)
- Notification of Emergency Response Agencies / Public
 - Pre-Emergency Declaration on 7 May 2003 (to Agencies / National Weather Service)
 - Press Releases (8 May 2003), Public Meetings
- Implement Drawdown Plan
 - Continual Monitoring (Drain Flows, Turbidity, Water Levels,
 Visual Inspection)
 - Stockpiling Resources, Equipment
 - Emergency Declaration / Reservoir Drawdown

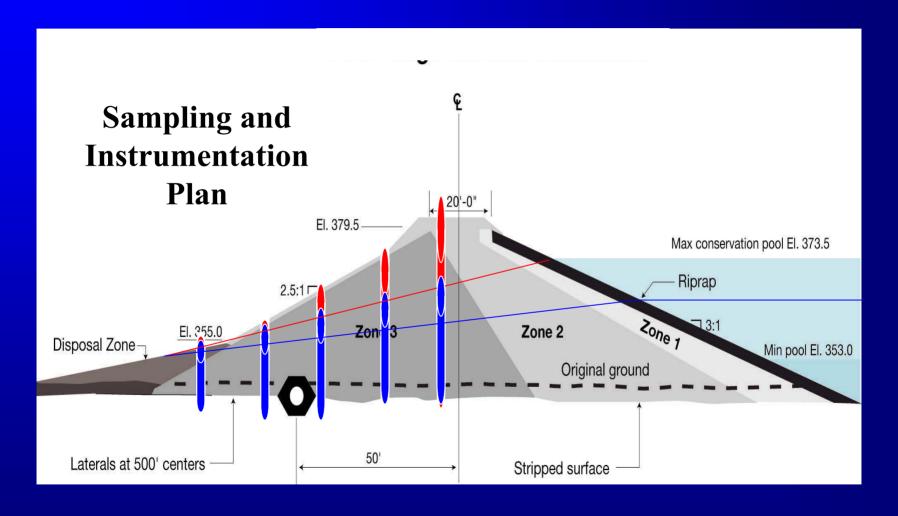
- Core Samples Materials Properties
- New Piezometers Water Levels (Saturation Level) in the Embankment
- Final Stability Analysis Actual Factor of Safety
- Determine New Maximum Water Levels for Future Summer and Winter Operation of the Reservoir (Until Repairs are Completed)
- Completed Report in August (Posted to Website https://www.nwp.usace.army.mil/issues/fernridge/welcome.htm)
